Build Care Oy
Äyritie 18
FI 01510 VANTAA
Finland

Determination of radon transmittance

The client delivered their product which was named ElaProof H to RISE Research Institute of Sweden on 2017-10-02. There were no signs of visible damage to the material on arrival. The material thickness was 0.8-1.2 mm, given by the client. The material was tested without joints. See Appendix 2 for a picture of the material.

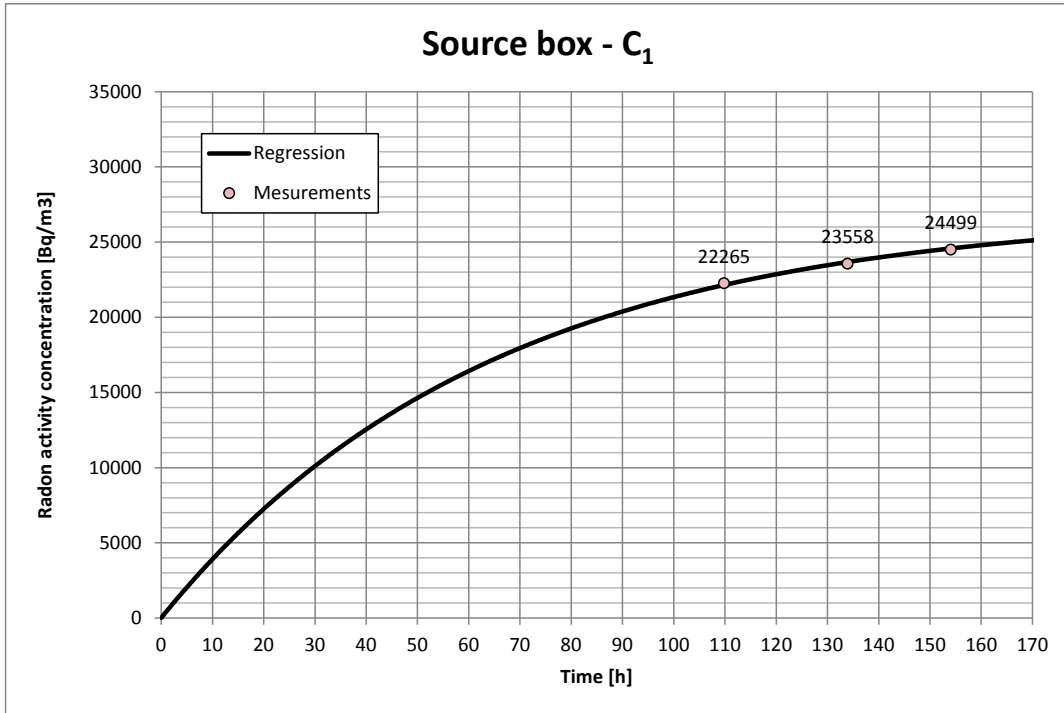
Figure 1 Radon concentration in the primary box: measured daily average values and the regression curve.

box. This difference causes a flow of radon by diffusion through the test material. Only radon gas (Rn) passes through, and not its decay products (RnD). Radon transmittance is measured by measuring the change in radon concentration on both sides of the test material. Figures 1 and 2 show how the radon concentrations build up in the two boxes.

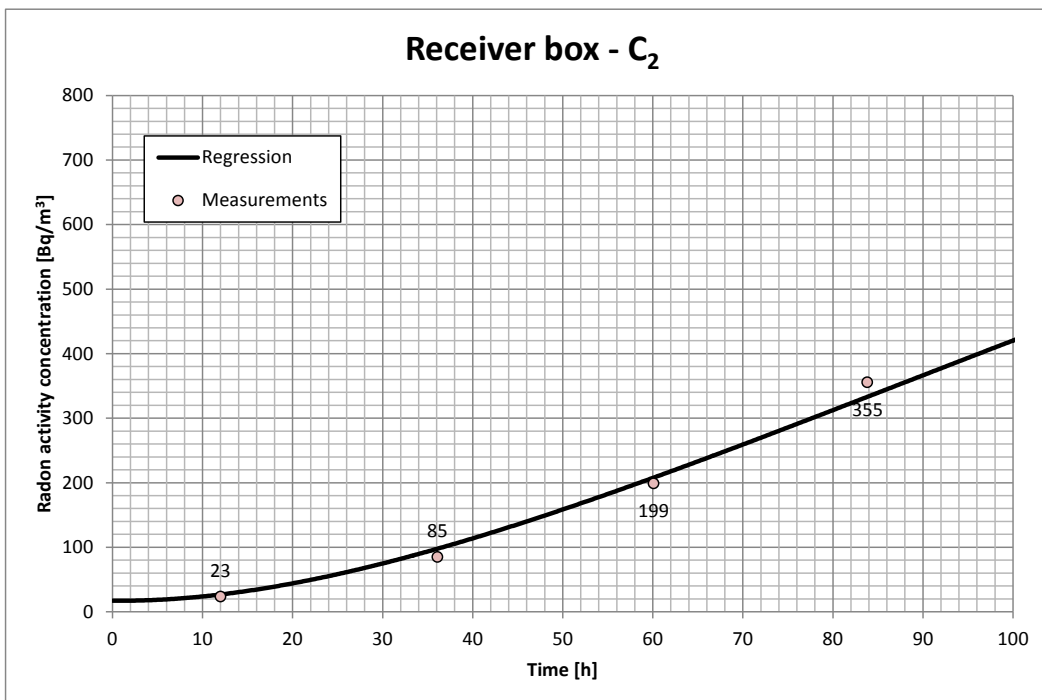
Figure 2 Radon concentration in the secondary box: measured daily average values and the regression curve.

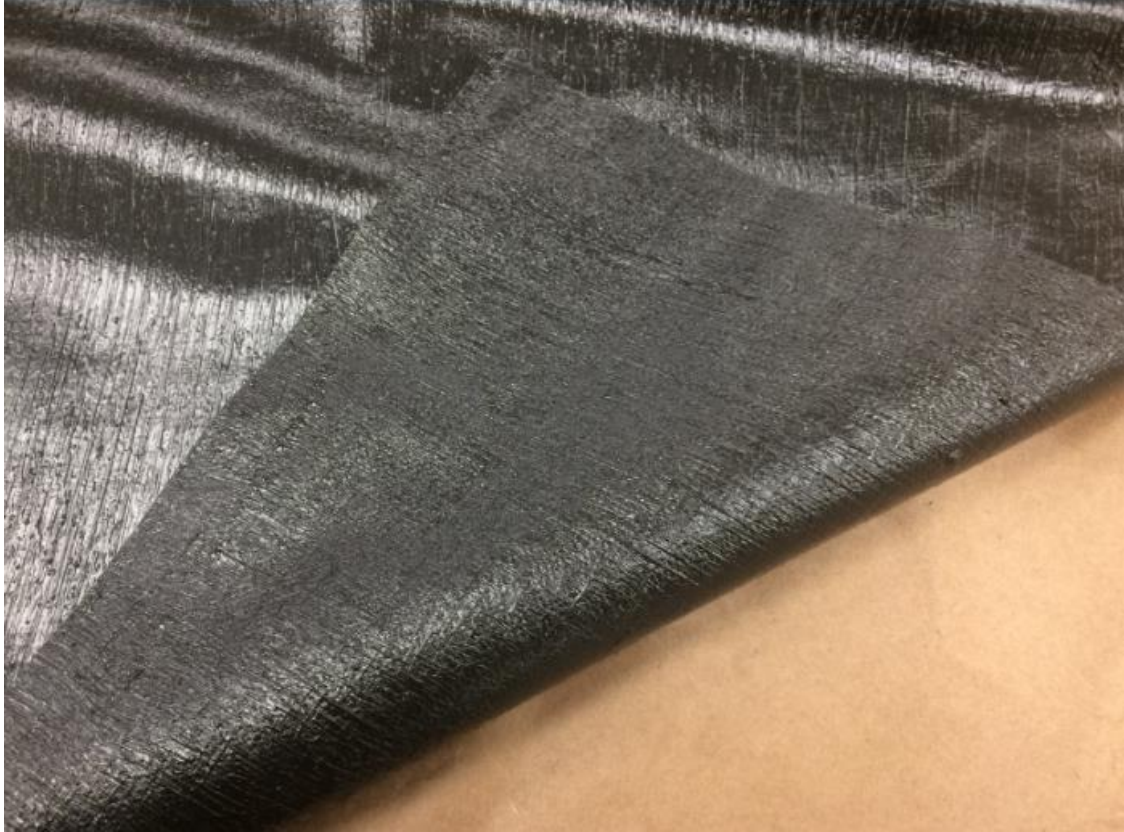
Photographs of the tested material
